TECHNICAL REPORT REMR-CO-3

CASE HISTORIES OF CORPS BREAKWATER  
AND JETTY STRUCTURES

Report 5

NORTH ATLANTIC DIVISION

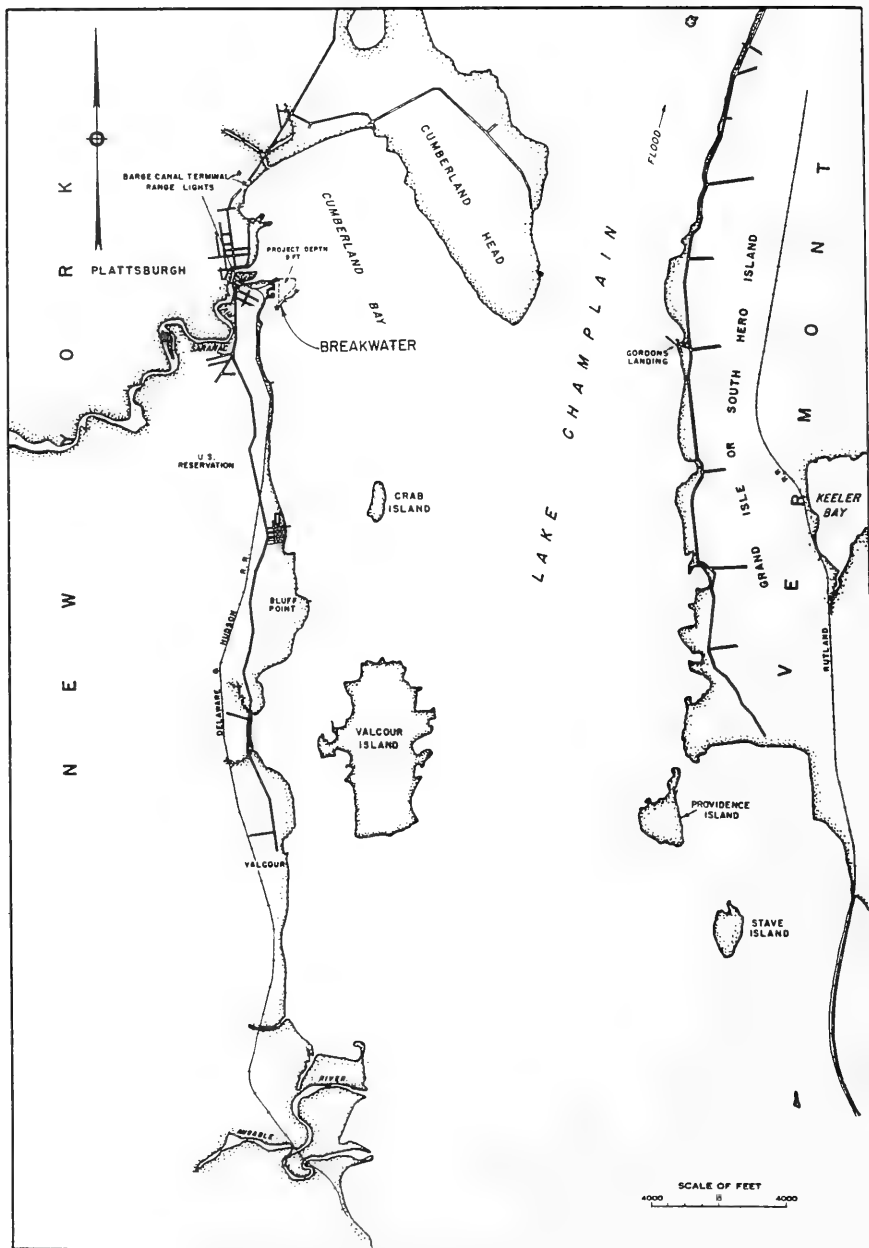
Figure 7. Plattsburgh Harbor, New York

<u>Date(s)</u>	<u>Construction and Rehabilitation History</u>
1836- 1875	1,250 ft of breakwater was constructed of timber cribs filled with rubblestone and capped with large stone. Slopes were 1:1, and the timber elevation was at low water level.
1893	The breakwater was extended to 1,565 ft (Figure 7). A total of \$32,500 was spent on renewal of the old timber superstructure by one composed of large facing stones with rubblestone core.
1949	A survey indicated the breakwater was in good condition except at the ends.
1971	Repairs were made to the north end of the breakwater at a cost of \$118,000.
1986	No further repair or maintenance information has been found.

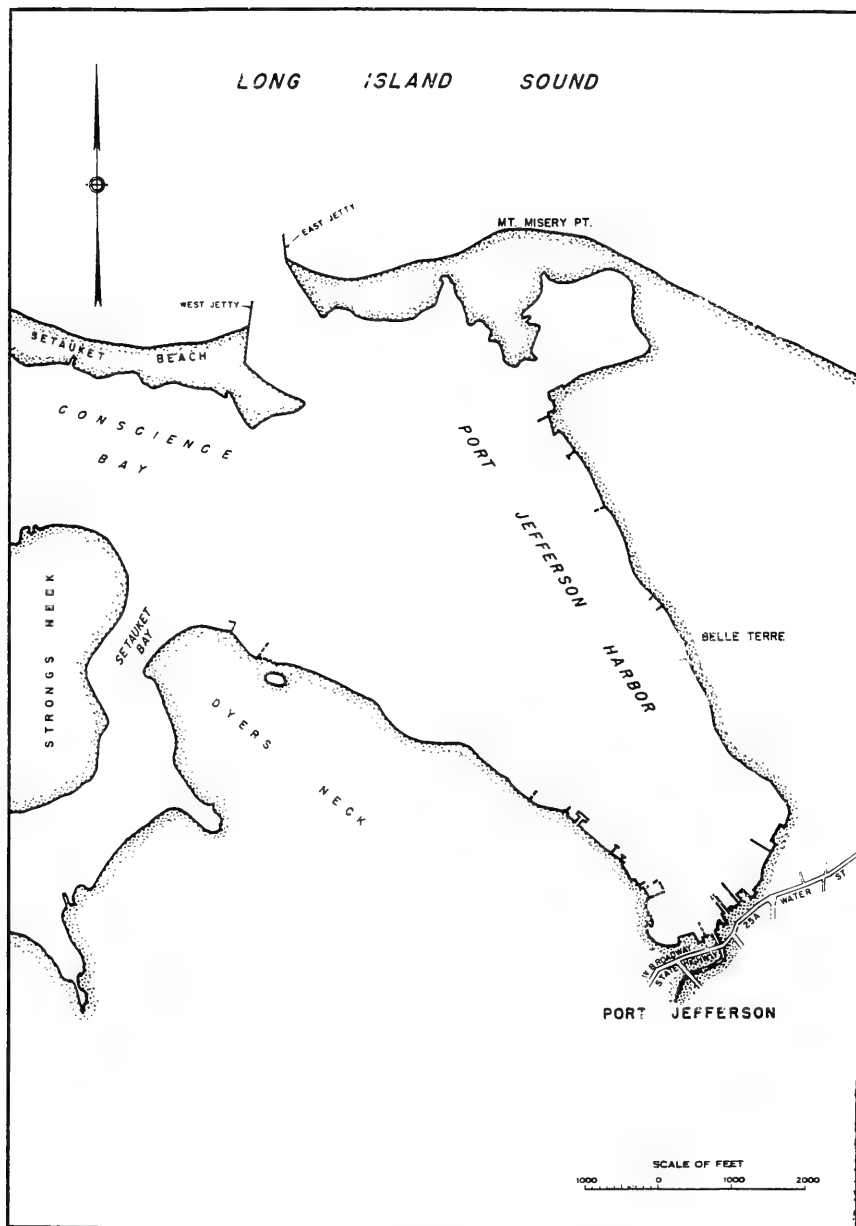
Figure 12. Port Jefferson Harbor, New York

1891	The east jetty was repaired over 600 ft with 1,464 tons of stone.
1908	The east jetty was extended to 1,550 ft (Figure 12).
1964	A survey indicated the jetties were in poor condition.
1986	No further repair or maintenance information has been found.

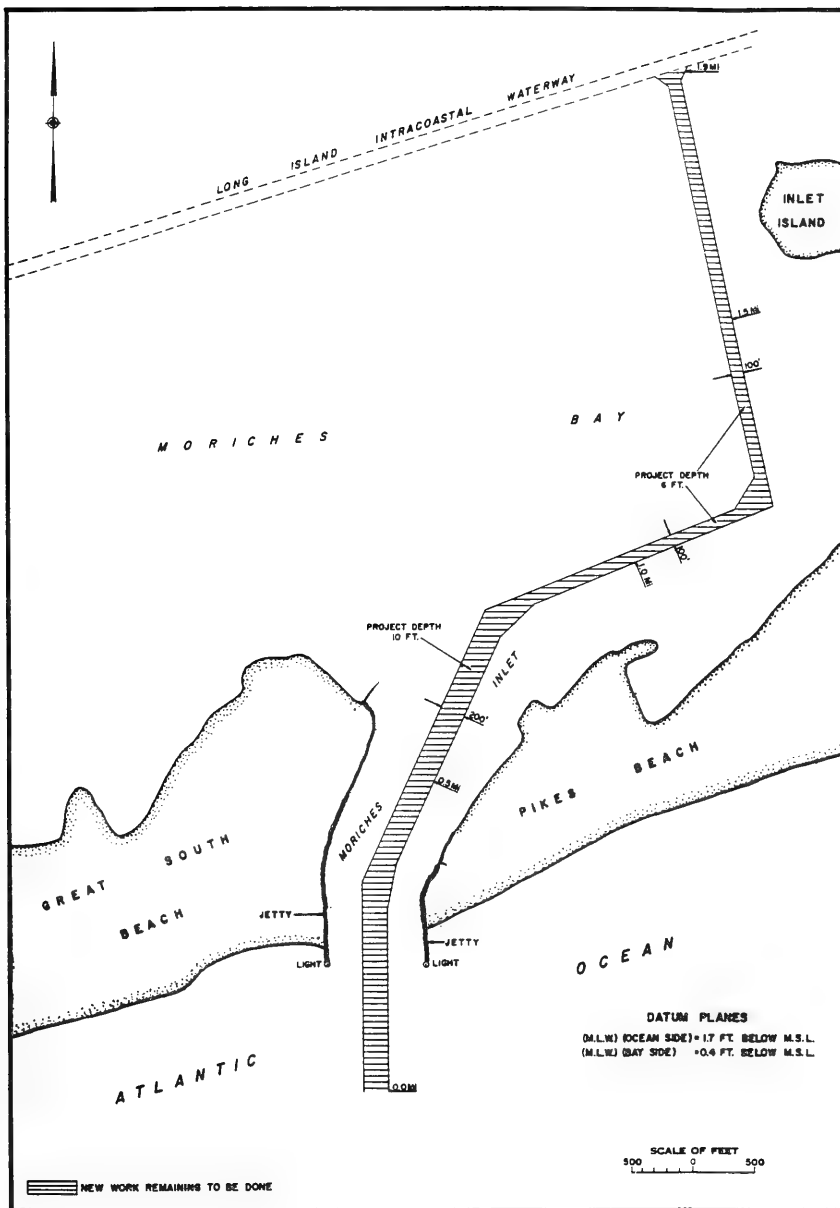
Figure 19. Moriches Inlet, New York

1954	Local interests extended the jetties to 841 ft east and 1,461 ft west (Figure 19) using 6.0- to 12.0-ton capstone at 1V:2H side slopes. Core stone used was 15 lb to 5.0 ton, east jetty, and 10 lb to 2.0 tons west jetty. A 2.0-ft-thick blanket and apron was placed using 15- to 500-lb stone. Jetty ends were approximately 800 ft apart. Cost was \$194,290 east and \$142,260 west.
1956	An inspection of the jetties was conducted. Stone on the inlet side of both jetties had slipped at numerous locations. Slope stones and capstones had unraveled at the outer end of the east jetty. Approximately 300 ft of the west jetty had settled 2.0 to 3.0 ft. The jetties had undergone severe wave attack since their construction, and most of the damage was attributed to the hurricane of August 31, 1954.
1983	A survey indicated the jetties were in a good, stable condition. The jetties had settled approximately 2.0 ft over 65 ft on the east jetty and 130 ft on the west jetty. The jetties did not meet Corps of Engineers standards for armor stone layer thickness, weight, or elevation, and it was determined that it would be more economical to maintain the jetties on an annual basis than by rehabilitation. Potential damage was anticipated to increase.

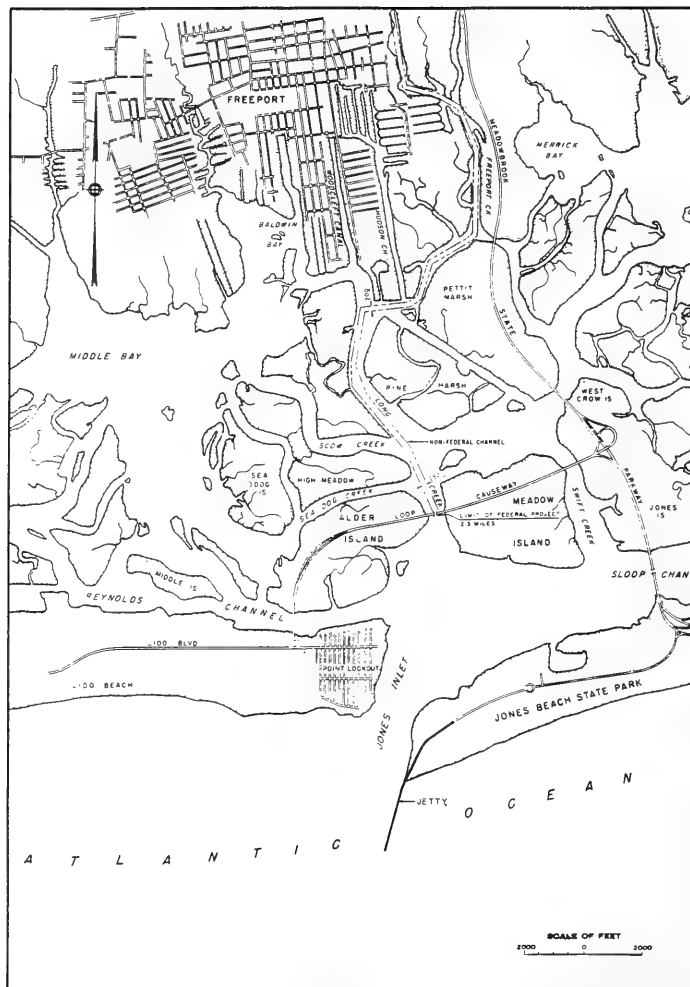
Figure 22. Jones Inlet, New York

1962	The Middle Atlantic coastal storm of 6-8 March 1962 damaged the jetty. The outer 200 ft was raveled and broken down to the high water level. A second layer of capstone was added to the outer 120 ft to restore the original design. The adjacent 1,080 ft shoreward was repaired by replacing armor stone and by adding stone. Armor stone was replaced on the adjacent 900 ft shoreward.
1985	The jetty had nearly reached impoundment. Sand was bypassing the jetty, mostly through large voids at the jetty-shoreline intersection. The apron had settled approximately 7.0 ft at the seaward end due to sand loss through voids in the apron.
1986	No further repair or maintenance information has been found.

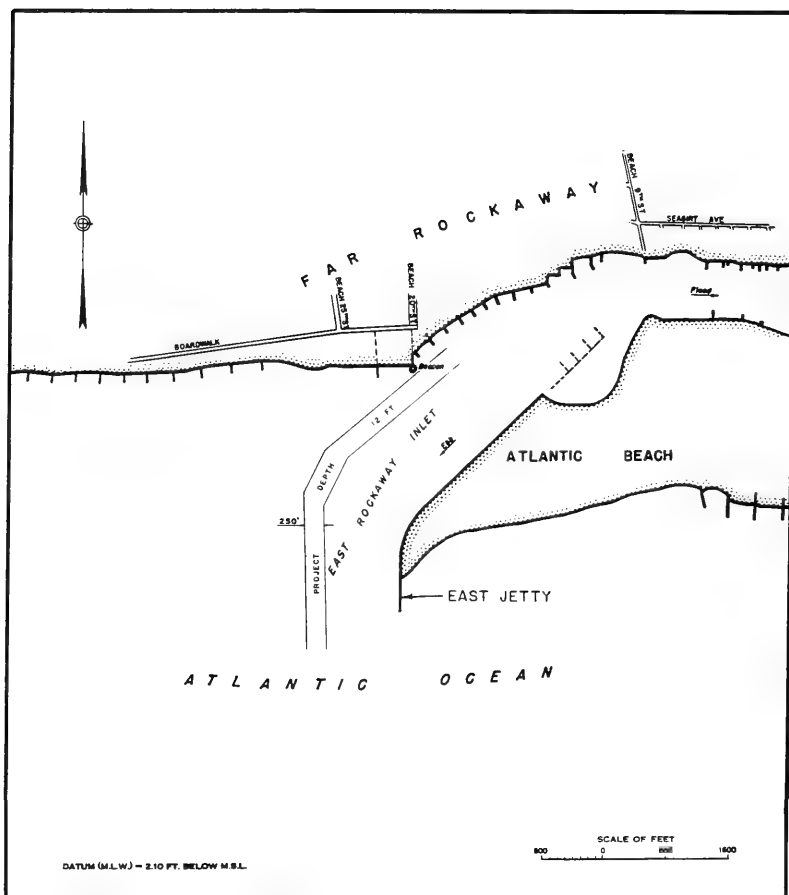
Figure 23. East Rockway (Debs) Inlet, New York

<u>Date(s)</u>	<u>Construction and Rehabilitation History</u>
1934	<p>A 3,750-ft-long jetty was constructed on the east side of the inlet for stabilization (Figure 23). The jetty was constructed in three sections with lengths of 1,400 ft, 1,400 ft, and 950 ft, landward to seaward, respectively. The design geometry for each section was:</p> <p>Section 1: Crest elevation of +8.0 ft mlw, 6.0-ft crown width, 1:1 side slopes, and one layer of cover and capstone.</p> <p>Section 2: Crest elevation of +8.0 ft mlw, 8.0-ft crown width, 1:1 side slopes, and one layer of cover and capstone.</p> <p>Section 3: Crest elevation of +10.0 ft mlw, 15.0-ft crown width, 1V:1.5H side slopes, and one layer cover and capstone.</p> <p>The jetty rested on a 1.0-ft-thick blanket and a 1.0-ft-thick apron which extended seaward of the toe 500 ft. A jetty was to be built west of the inlet if necessary.</p>
1935	Repairs were made to the jetty beginning 2,500 ft from the landward end, and extending seaward 250 ft. The cost of repairs was \$14,426, and 1,926 tons of stone were used.

1941	Repairs were made by rearranging 212 tons of stone on the seaward 610 ft at a cost of \$6,000. An additional 375 tons were placed on the east side of the seaward end at a cost of \$1,670.
1946	Twenty-four hundred tons of stone were placed on the jetty at a cost of \$78,000. The jetty was considered to be in good condition.
1963	Repairs were made using 800 tons of stone at a cost of \$18,411, and the structure was in good condition with the exception of minor repairs.
1986	No further repair or maintenance information is available on the east jetty. The west jetty has not been built. The project has been deauthorized.

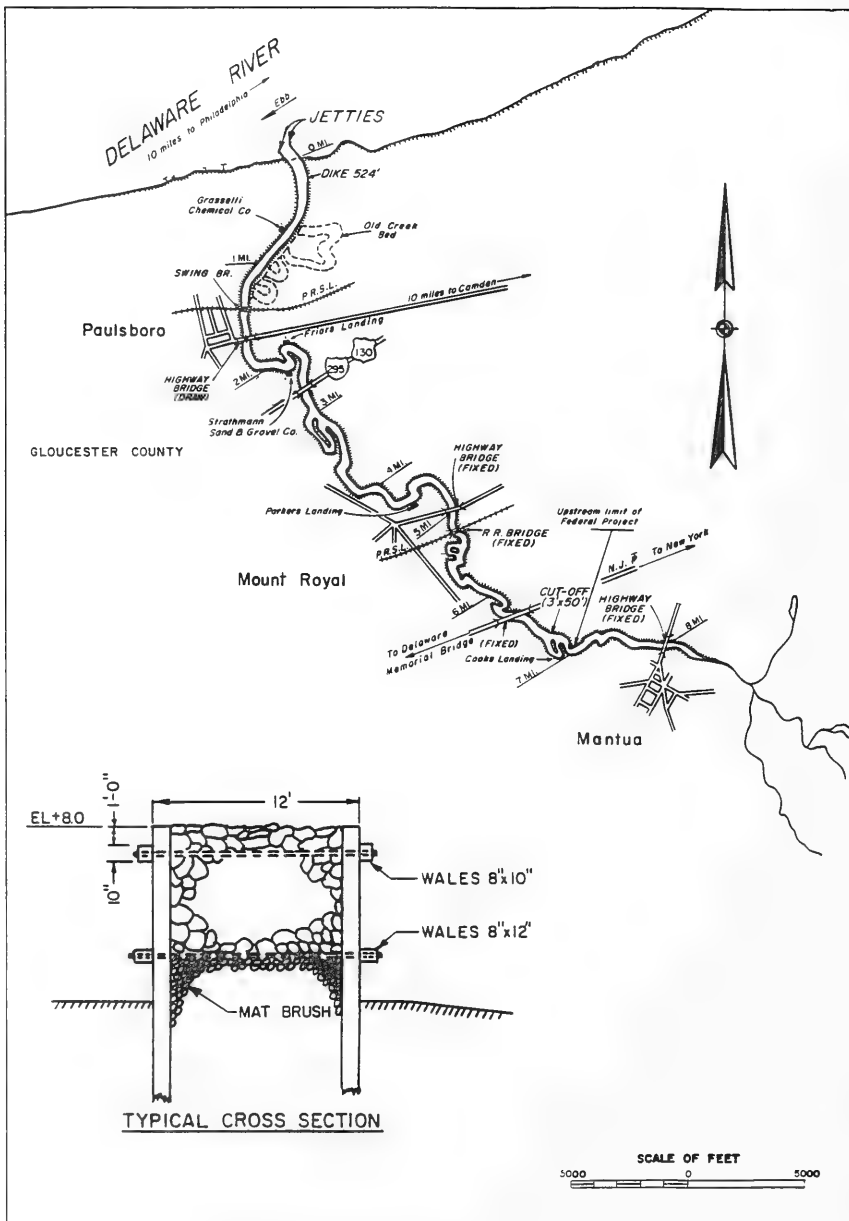
Figure 28. Mantua Creek, New Jersey

<u>Date(s)</u>	<u>Construction and Rehabilitation History</u>
1907	Two jetties were constructed to provide channel protection. Lengths were 754 ft and 580 ft east and west, respectively. The jetties were constructed of stone-filled timber cribs, with mat brush placed to support the stone (Figure 28). Top width and elevation were 12.0 ft and +8.0 ft mlw, respectively, for each jetty.
1912-1913	The east jetty was extended to 1,577 ft, and the west jetty was extended to 1,456 ft (Figure 28).
1918	Repairs were made by the addition of stone.
1962	An investigation of the jetties revealed the jetties had settled an average of 2.0 ft. Approximately 100 ft of the offshore end of the east jetty had deteriorated, with most of the pilings gone, and stone had fallen out to below the waterline. Most of the walings had deteriorated and were missing. Piles were missing at intermediate locations along the jetties, but there was no significant loss of stone at those locations. Piles that remained were in good condition.

1963	The jetties were rehabilitated at a cost of \$136,895. A new row of piles was placed over approximately 100 ft at the offshore ends. Piles were placed 7.5 ft on either side of the center line of the jetties. Corestone was dumped between the piles to an elevation of +8.0 ft mlw (Figure 29). Missing piles were replaced, and new wales were provided along the remainder of the jetties. One row of capstone was placed on the inner sides of both cribs on top of the existing stone to +8.0 ft mlw. Core stone was filled between the capstones in the center of the jetties to +8.0 ft mlw (Figure 29). Crown width was 16.0 ft at the offshore ends and 12.0 ft on the remainder of the jetty. Design wave height was 4.2 ft.
1964	Repairs were made to the seaward end of the east jetty at a cost of \$4,864. The Corps was reimbursed later for this work.
1986	No further repair or maintenance information has been found.

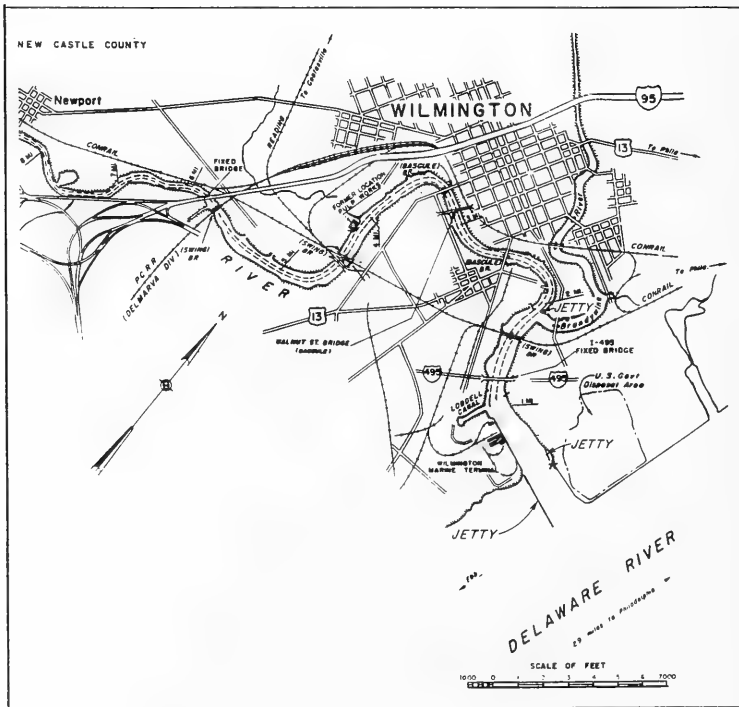
Figure 31. Wilmington Harbor, Delaware

Date(s)	Construction and Rehabilitation History
1937- 1939, 1948	Damages to the Christina south jetty, caused by ships colliding with it, were repaired each of these years at a total cost of \$90,000.
1961	The landward 500 ft of the Christina south jetty was removed to accommodate marine terminal expansion. The total length of the jetty was 1,800 ft.
1962	275 ft of buttressed steel sheet-pile wall failed during an extremely low tide and was eventually repaired.
1985	The Christina south jetty is in good condition.

1905	Repairs were made to the Brandywine River jetty and the north Christina River jetty. New wales were put on the Brandywine jetty, and face timber was replaced on the north Christina jetty. Stone was replaced where needed on both jetties.
1916	Repairs were made to the north Christina River jetty. Broken timber and piling was replaced with new material. Fender piles were placed along the channel face, and the interior of the crib was filled with stone where settling had occurred along the entire length of the jetty.
1925	The south jetty was removed, and a new jetty was to be built south of the Christina River.
1931	Approximately 1,200 ft of the north jetty was removed to improve the channel regime. The total length of the north jetty was 950 ft (Figure 31).
1936	A new jetty was completed south of the Christina River mouth. The jetty was 2,300 ft long (Figure 31) and consisted of 1,352 lin ft of steel sheet-pile wall, buttressed with 100-ft timber piles 12 ft on center, a 948-ft outboard section consisting of twelve 25.5-ft-diameter steel sheet-pile cells, and one 30.5-ft-diameter terminal cell with twelve 51-ft interconnecting fences. Crest elevation was +10 ft Corps of Engineers Datum (2.9 ft below mean sea level, 1929). The landward end of the jetty was connected to shore by a 120-ft steel sheet-pile anchor wall. The cost of construction was \$205,000.

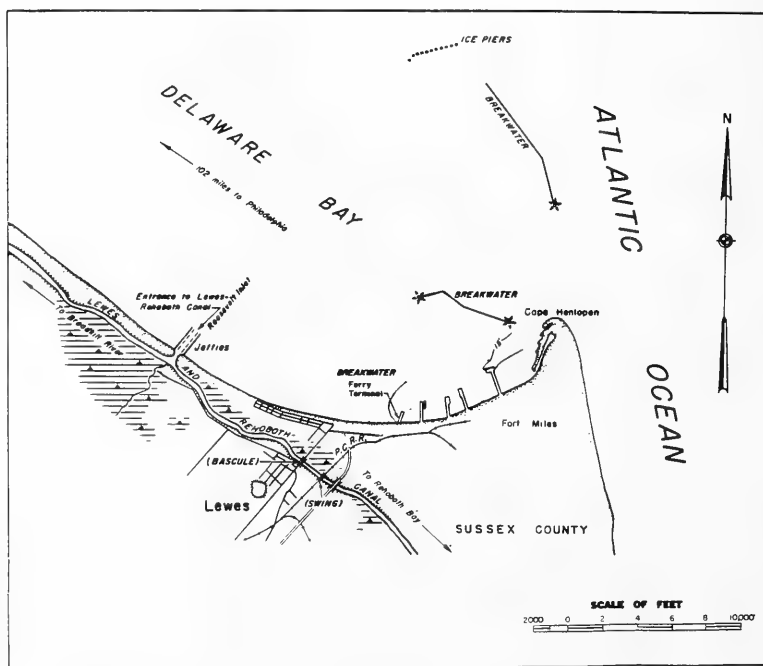
Figure 37. Delaware Bay Harbor of Refuge, Delaware

<u>Date(s)</u>	<u>Construction and Rehabilitation History</u>
1898	A 5,000-ft-long detached breakwater was completed to offer harbor protection from east-northeast storms. The structure was located 2,800 ft west of Cape Henlopen and extended west-northwest (Figure 37). The cost of construction was \$2,790,000.
1901	Construction was completed on a second detached breakwater to provide harbor protection from northwest storms (Figure 37). The structure began at a point 6,000 ft north of Cape Henlopen and extended northwest 7,500 ft. The rubble-mound breakwater was constructed with 1,475,276 tons of stone at a cost of \$2,239,000.
1985	The breakwaters have no history of repairs and have survived remarkably well. The structures are outdated and would not be repaired if damaged. They no longer serve their intended purpose because of changes in the shipping industry.

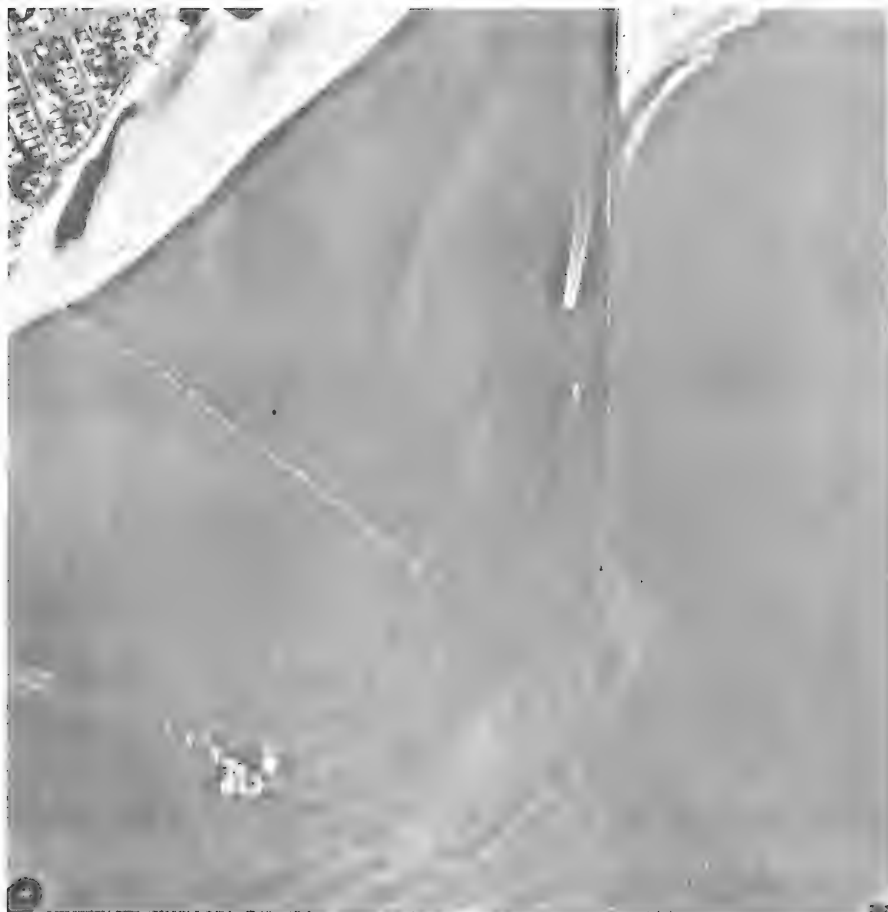
Figure 41. Photograph of Barnegat Inlet jetties

<u>Date(s)</u>	<u>Construction and Rehabilitation History</u>
1940	Two converging stone jetties were constructed north and south of the inlet for channel protection. The north jetty was 4,675 ft long, and the south jetty was 2,820 ft long (Figure 40). Design crest elevation was +2.0 ft mlw.
1944	The shoreward 100 ft of the south jetty was lowered.
1950	Repairs were made to the seaward end of the north jetty.
1954	Repairs were made to the shoreward portion of the south jetty.
1972- 1974	To prevent sand passing through and waves overtopping the north jetty, the shoreward 3,700 ft was raised to +8.0 ft mlw and made impermeable. The center line of the section repaired was offset 12.0 ft toward the inlet from the existing section (Figure 40).
1985	Due to instability and continuous shoaling of the navigation channel, proposals are being considered to construct a new south jetty. Portions of the jetties have crest elevations of +10.0 ft mlw. These sections were probably built as part of repair work conducted in 1950 and 1954. Figure 41 is an aerial photograph of the jetties in 1984.

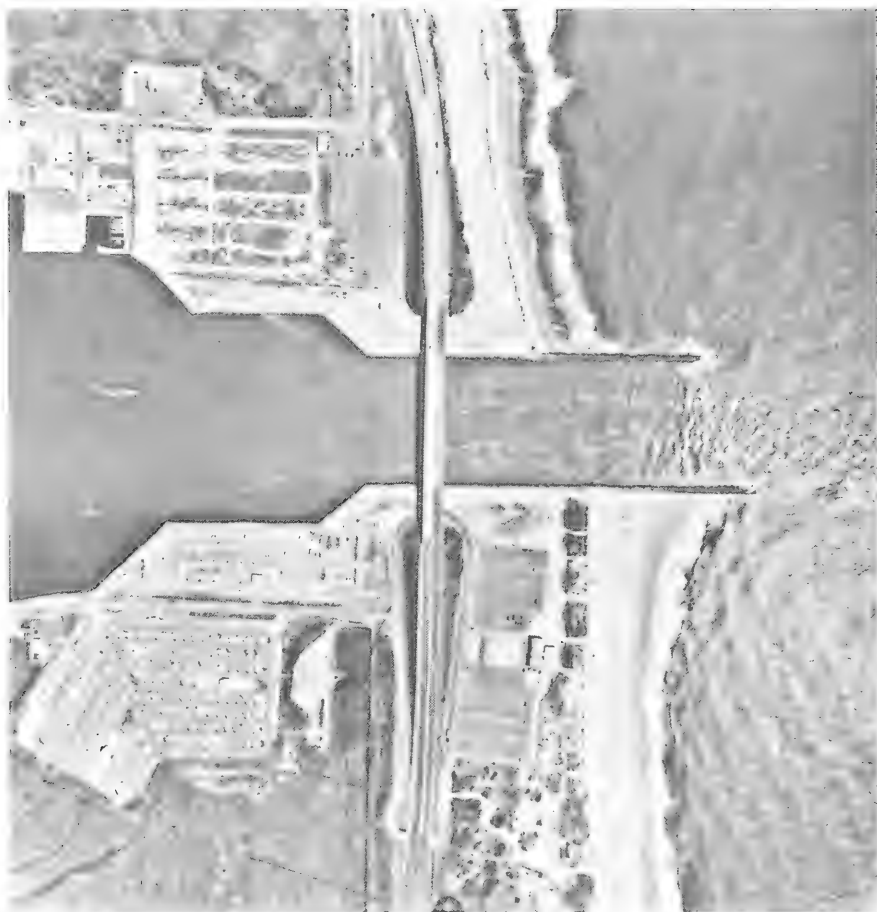
Figure 50. Photograph of Indian River Inlet jetties

<u>Date(s)</u>	<u>Construction and Rehabilitation History</u>
1939	Two parallel jetties were completed to provide inlet protection. The jetties were 1,566 ft long and 500 ft apart. The shoreward 904 ft and 890 ft of the north and south jetties, respectively, were constructed of steel sheet pile, and the seaward portions were constructed of stone. The stone jetties had a crest elevation of +6.0 ft mlw, a crown width of 10.0 ft, and side slopes of 1V:1.5H (Figure 49).
1956	Storm damages to the south jetty were repaired.
1957	The north jetty was repaired because of storm damages and was extended shoreward 320 ft because of shoreline recession and deterioration of the sheet pile (Figure 49).
1985	The jetty heads are in poor condition because of slope failure, subsidence, and toe scour. Repair alternatives have been proposed, and the use of dolosse has been suggested. Figure 50 is an aerial photograph of the jetties taken in 1985.

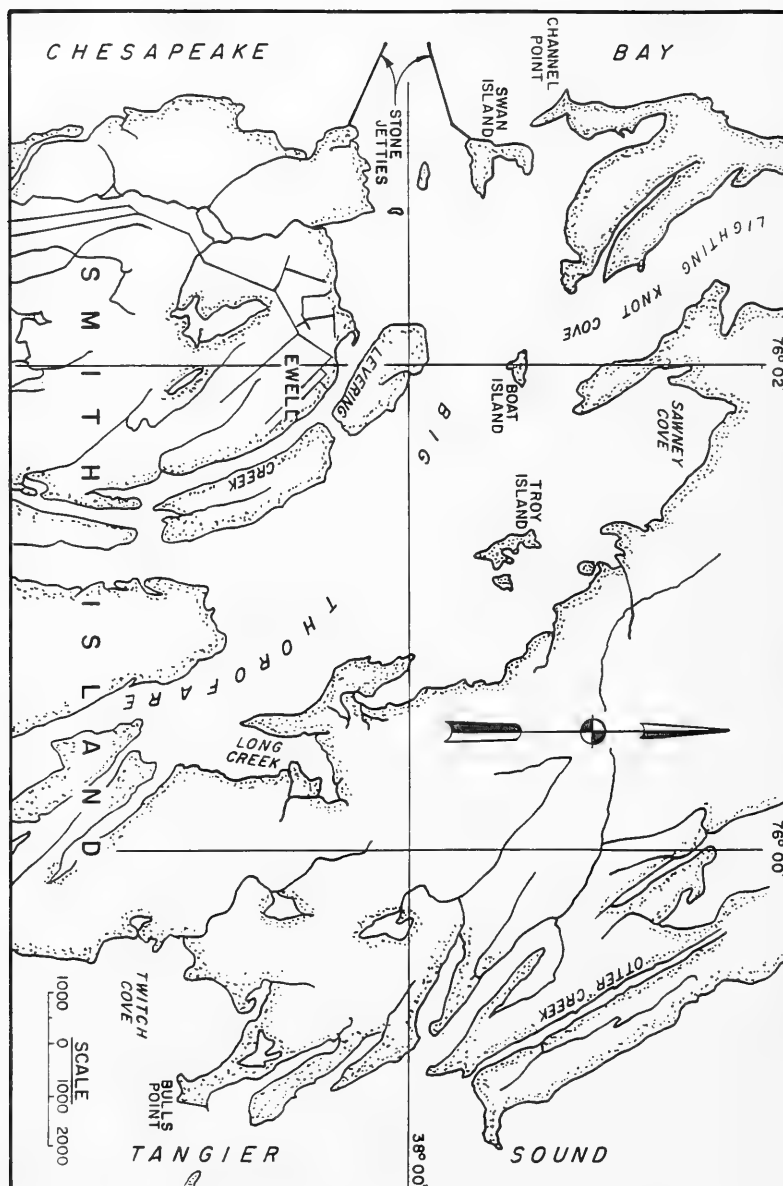
Figure 61. Twitch Cove and Big Thorofare River, Maryland

Date(s)	Construction and Rehabilitation History
1940	Two converging stone jetties were constructed with 23,000 tons of stone at a cost of \$112,000 (Figure 61). The north jetty was 2,070 ft long, and the south jetty was 1,800 ft long. The design section included a crown elevation of +4.0 ft mlw, a crown width of 2.0 ft with the exception of the seaward 120 ft of the north jetty which was 4.0 ft, and side slopes of 1V:2H, except for the bay side of the north jetty which was designed for 1:1 along the landward 1,950 ft. No stone size details were given; however, a 1981 survey indicated the side slope stone was approximately 1.5 tons, and the core was of similar stone. The survey also revealed the single cap-stone ranged from 2.0 to 3.0 tons. No apron or bedding was placed during construction or subsequent repairs.
1945	A condition survey was performed which indicated the north jetty was in a severe state of deterioration. The seaward 1,300 ft of this jetty had a typical subsidence of 0.5 ft below the original elevation, and the seaward 300 ft of this section had a range of subsidence of 2.0 to 4.0 ft. The south jetty was flanked, and the seaward 400 ft of the south jetty had subsided 0.5 to 1.5 ft. The seaward end of this section had subsided below mlw. Toe areas had scoured from -5.0 to -7.0 ft mlw.

1952	A condition survey was made on the north jetty. The seaward 570 ft had a range of subsidence from 2.0 to 5.0 ft, and 700 ft landward of this section had subsided 1.0 to 2.0 ft. Jetty cross sections indicated most of the subsidence occurred on the bay side. Repairs were made to the seaward 1,030 ft of the north jetty using original design geometry to raise the crest elevation to +3.0 ft mlw. The cost of the repairs and dredging was \$33,000.
1955- 1956	A condition survey performed on the south jetty indicated an average subsidence of 0.5 ft over the entire length. The seaward 300 ft had subsided 2.0 to 4.0 ft, and a length of 80 ft had subsided near the landward end. Areas of subsidence were typically 1.0 to 2.0 ft below adjacent sections. Repair work began in 1956 to raise the crest elevation to +3.5 ft mlw using original design geometry. Approximately 1,000 tons of stone were used at a cost of about \$35,000 which included dredging. Toe areas had scoured to -9.0 ft mlw.

1962	Both jetties were surveyed and repaired with 2,200 tons of stone for approximately \$64,500. The north jetty had been flanked on the landward end, and elevations of the seaward 520 ft ranged from +1.0 to +3.0 ft mlw. The seaward 180 ft of the south jetty had elevations ranging from 0.0 to +4.0 ft mlw. The above sections were repaired to

Date(s)	Construction and Rehabilitation History
1962 (Cont.)	a crown elevation of +4.0 ft mlw, with a 2.0-ft crown width, except the seaward 70 ft of the north jetty was 4.0 ft. The side slopes were 1V:2H. The landward end of the north jetty was extended 120 ft. Voids along the remainder of the jetties were repaired by placing and resetting existing stone at existing section elevations. The depth at the toes of the jetties ranged from 10.0 to 12.0 ft mlw.
1981	<p>A survey report indicates both jetties are in "poor" condition. The seaward end of the north jetty and the landward ends of both jetties were flanked, and there were numerous areas of subsidence along their lengths. It is believed that scour is the reason for their deterioration for the following reasons:</p> <ul style="list-style-type: none"> <li>-- Existence of a homogeneous cross section (no smaller core placed).</li> <li>-- No bedding stone or apron stone being placed during original construction or during repairs.</li> <li>-- Increase in depth from a range of 5.0 to 6.0 ft to a range of 10.0 to 12.0 ft mlw at the seaward ends.</li> <li>-- Landward ends of the jetties being flanked at present. Each has been flanked once and repaired since original construction.</li> <li>-- General subsidence along the entire lengths of the jetties of 0.5 to 1.0 ft.</li> <li>-- Numerous voids or gaps where capstones were missing.</li> </ul>

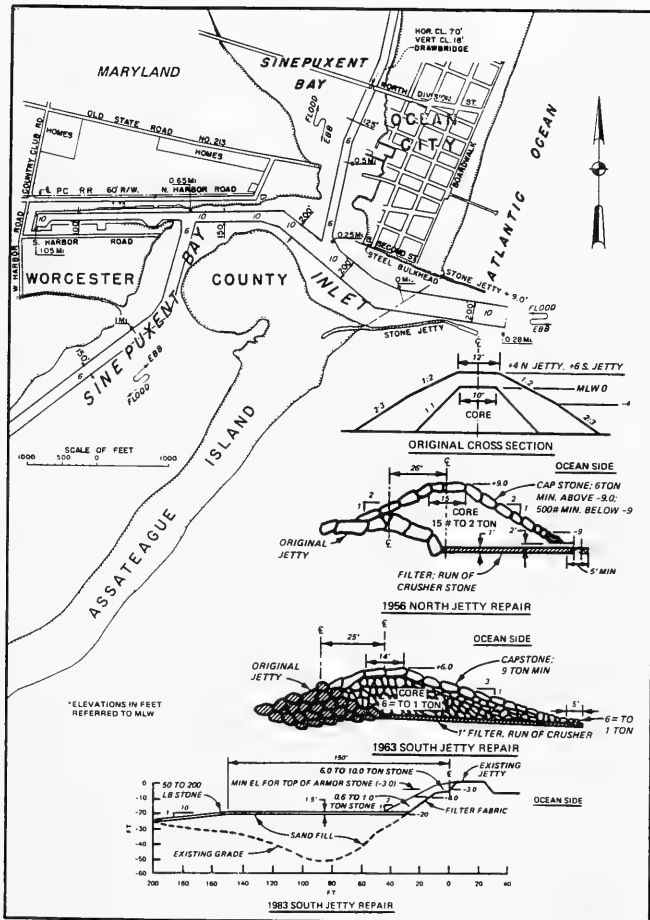
Figure 62. Ocean City Inlet, Maryland

Date(s)	Construction and Rehabilitation History
1934	A 1,100-ft-long jetty was constructed on the north side of a newly formed inlet at Ocean City (Figure 62). Crest elevation was +4.0 mlw, crown width was 12.0 ft, and side slopes were 1V:2H from the crest to -4.0 mlw and 1V:1.5H from -4.0 mlw to the bottom.
1935	Construction was completed on a jetty on the south side of the inlet. Crest elevation was +6.0 ft mlw, and crown width was 12.0 ft. The landward 750 ft of the jetty was 1,100 ft south of the north jetty. The south jetty angled north 1,100 ft to a point 600 ft from the north jetty. The final 530 ft of the south jetty was parallel to that of the north jetty. The crest elevation decreased from +6.0 ft mlw to the apron elevation beginning 170 ft seaward of this final section. The apron extended 200 ft farther seaward. The total length of the jetty was 2,380 ft, including the apron. A total of 39,500 tons of stone was used for core; 17,300 tons were used for capstone on the south jetty.

1937	Sand on the north side of the north jetty had reached the top of the jetty and was depositing in the inlet. A concrete superstructure was built to raise the jetty elevation. The first 100 ft from the boardwalk was raised to +12.0 ft mlw, the next 254 ft was raised to +9.0 ft, and the next 170 ft was raised to +7.0 ft mlw.
1956	Repairs were made on the seaward 750 ft of the north jetty because of slope failures on the channel side from toe scour. The existing concrete cap was repaired and raised to +9.0 ft. Armor stone was placed on the seaward 575 ft. The armor stone section was placed 26 ft north of the center line to use existing stone as toe protection and to minimize the stone required. The landward end of the south jetty was repaired to maintain integrity with the shoreline.
1963	Approximately 720 ft of the south jetty was rehabilitated due to slope failures caused by a scour hole that had an elevation of -37 ft mlw. Armor stone was placed 25 ft seaward of the center line for the same reasons stated above in positioning the north jetty. The landward end of the south jetty was again repaired to maintain integrity with the shoreline.

1984	The seaward 1,100 ft of the south jetty was rehabilitated due to slope failures. The section repaired in 1963 had deteriorated. The scour hole had a maximum depth of -54 ft mlw. Repairs consisted of filling the scour hole with dredged material to -20 ft mlw, covering the hole with 18 in. of blanket stone, and placing stone berm quarry run and armor stone along the toe on the channel side of the

Date(s)	Construction and Rehabilitation History
1984 (Cont.)	existing jetty. The landward end of the south jetty was sand tightened to prevent material from passing through the jetty and shoaling into the channel. Three rubble mound breakwaters were constructed landward of the jetty to prevent expected erosion from occurring as a result of sand tightening.
1986	No further repair or maintenance information has been found.

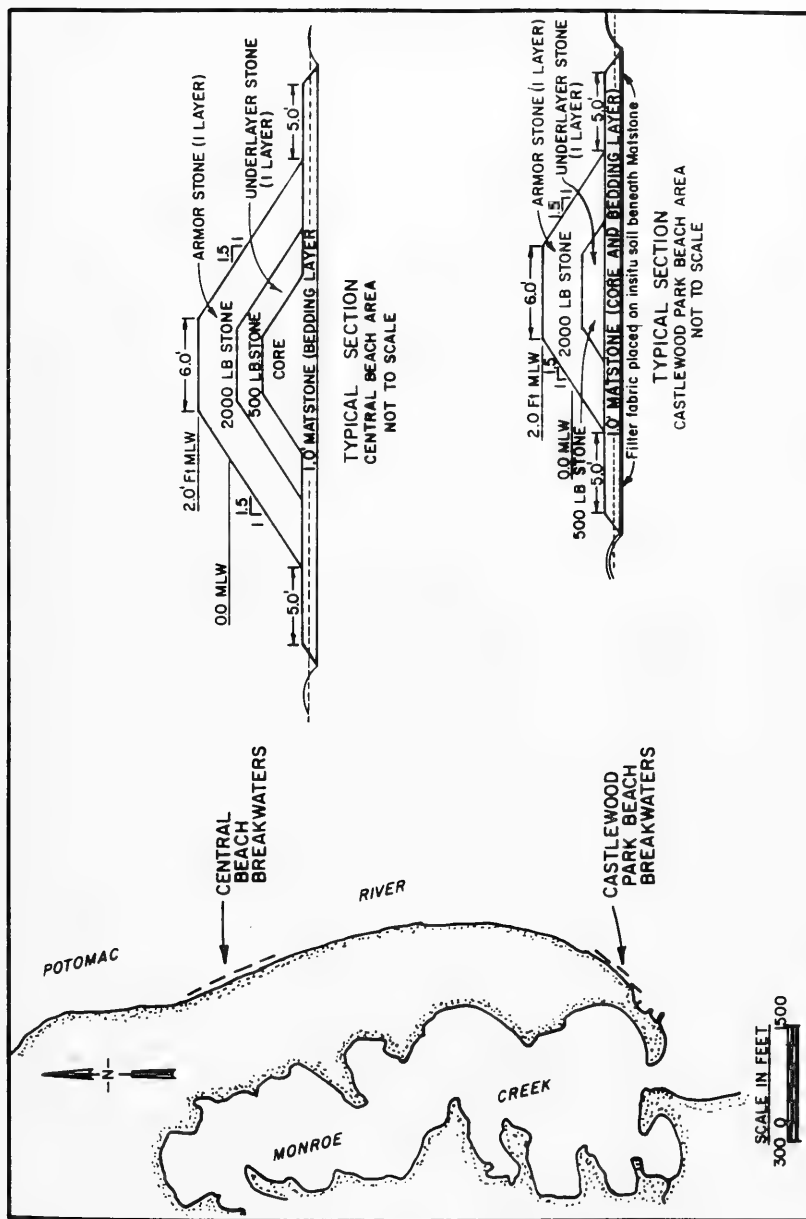
Figure 63. Colonial Beach, Virginia

<u>Date(s)</u>	<u>Construction and Rehabilitation History</u>
1982	Seven offshore breakwaters were constructed as part of a beach restoration project for approximately \$447,000, using over 9,000 tons of stone (Figure 63). One 300-ft breakwater and two 200-ft breakwaters were placed at Castlewood Beach, and four 200-ft breakwaters were placed at Central Beach. All were placed parallel to the shoreline and approximately 100 ft offshore, and they were separated by 150-ft gaps. Crest elevations were +3.0 ft mlw but allowed for settlement to +2.0 ft mlw. Crown widths were 6.0 ft, and side slopes were 1V:1.5H. One layer of 2,000-lb cover stone was placed over one layer of 500-lb underlayer resting on a core and 1 ft bedding layer. Design wave height was 6.0 ft.
1985	The breakwaters are in excellent condition and serving their intended function.

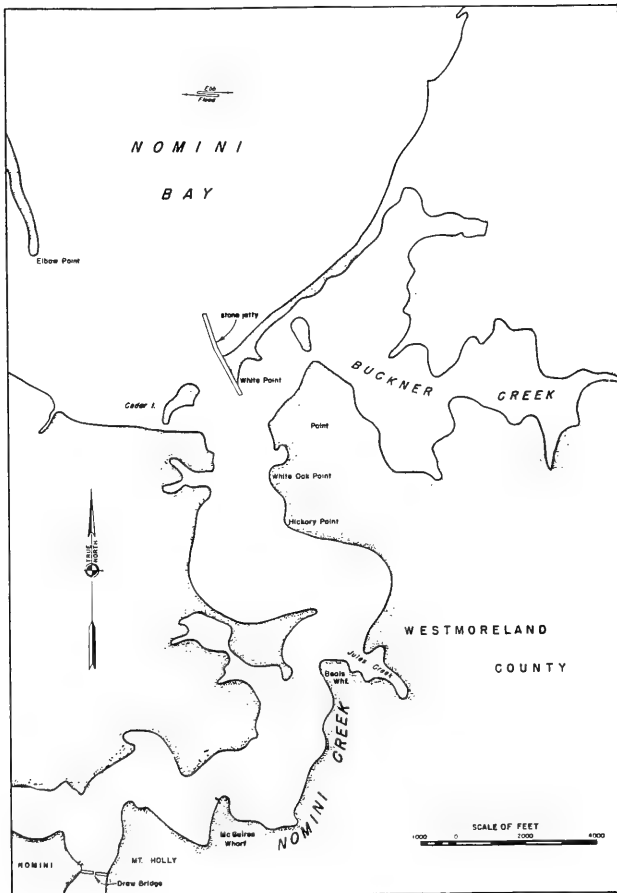
Figure 64. Nomini Bay and Creek, Virginia

<u>Date(s)</u>	<u>Construction and Rehabilitation History</u>
1912	A 2,410-ft-long stone jetty was completed (Figure 64).
1981	A survey indicated the jetty was in good condition.
1986	No further repair or maintenance information has been found.

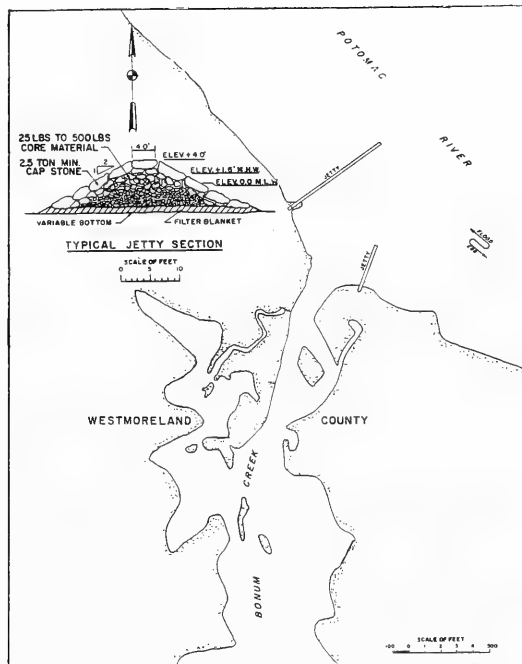
Figure 65. Bonum Creek, Virginia

<u>Date(s)</u>	<u>Construction and Rehabilitation History</u>
1968	Construction was completed on two stone jetties at an estimated cost of \$221,000 using 8,000 tons of stone. The north jetty was 800 ft long, and the south jetty was 300 ft long (Figure 65). Crown elevation was +4.0 ft mlw, crown width was 4.0 ft with a single capstone, and side slopes were 1V:2H. Cover stone used was 2.5 tons, and core stone ranged from 25 to 500 lb. Design wave height was 9.0 ft.
1981	A condition survey revealed that the jetties had undergone some settlement but were in good condition.
1986	No further repair or maintenance information has been found.

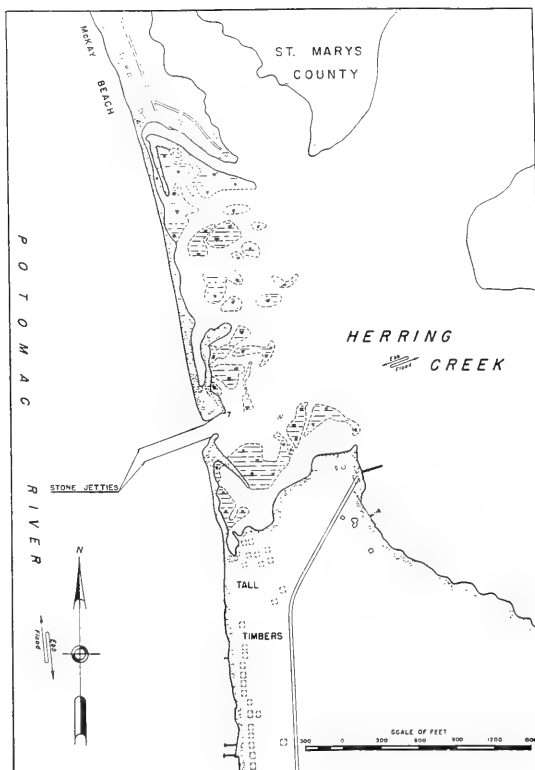
Figure 66. Herring Creek, Maryland

Date(s)	Construction and Rehabilitation History
1960-1961	Two jetties were constructed to 750- and 700-ft lengths north and south, respectively (Figure 66). Crown elevation was +4.5 ft mlw, crown width was 4.0 ft, and side slopes were 1V:2.5H. A 1.0-ft-thick bedding layer was placed, and a 1.0-ft-thick by 10.0-ft-wide apron was placed along both jetty toes.
1981	A survey indicated the jetties were in good condition with only minor settlement.
1986	No further repair or maintenance information has been found.

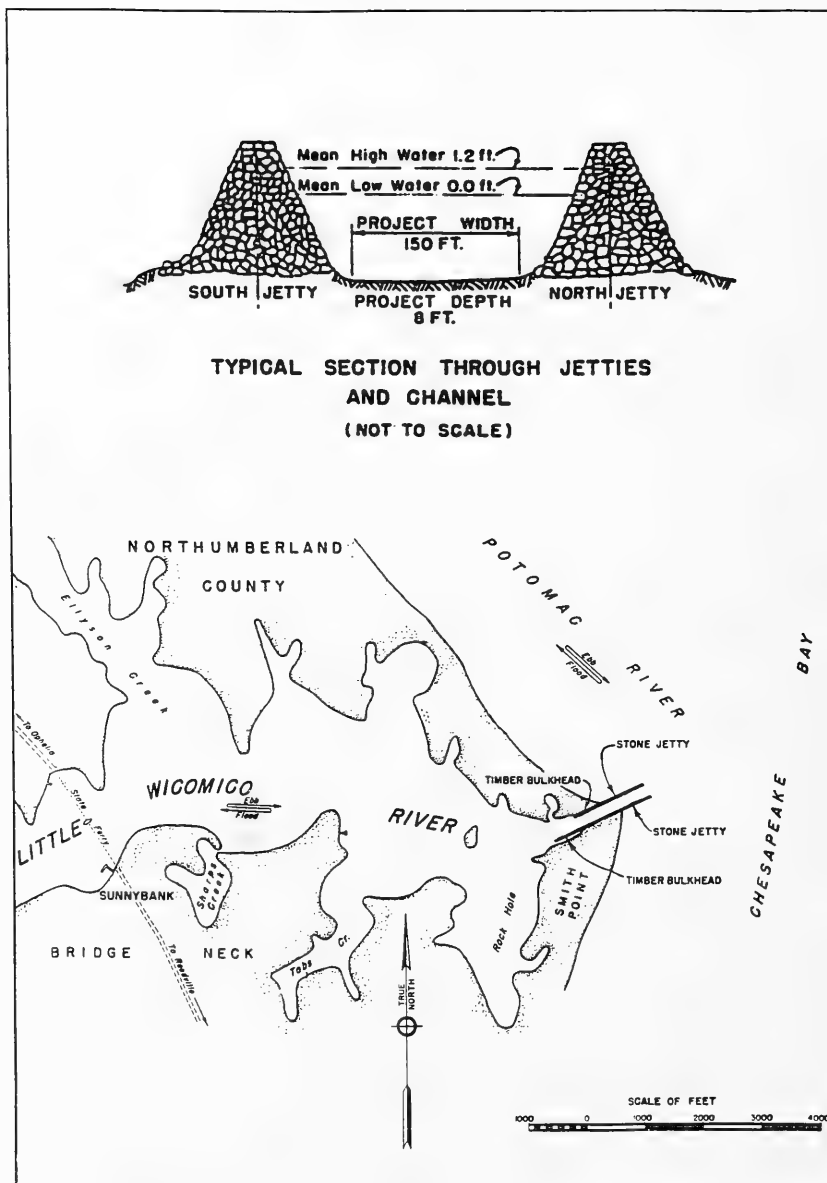
Figure 67. Little Wicomico River, Virginia

<u>Date(s)</u>	<u>Construction and Rehabilitation History</u>
1937	Two stone jetties were constructed to lengths of 1,000 and 1,300 ft north and south, respectively (Figure 67). Timber pile jetties were also placed at the landward ends of the stone jetties. Lengths of the timber piles were 357 ft north and 650 ft south.
1970	The north timber pile jetty was repaired at a cost of \$51,822.
1981	Survey of the jetties indicated the seaward 300 ft of each jetty had crown elevations ranging from -2.0 to +6.0 ft and no semblance of a crown width.
1985	The jetties were to be rehabilitated to minimize shoaling of the federal channel. The seaward 290 ft of each jetty was to be made sand tight by placing core stone and cover stone on the outer face at a 1-V:1.5-H slope. Crown elevation was to be +4.0 ft mlw, with a crown width up to 15.0 ft along the sections with crown elevations below +4.0 ft mlw. Toe protection was to be provided by a 2.0-ft-thick by 5.0-ft-wide extension of the core stone. A double layer of 1.0-ton cover stone was to be used. It is not known if the work was done.

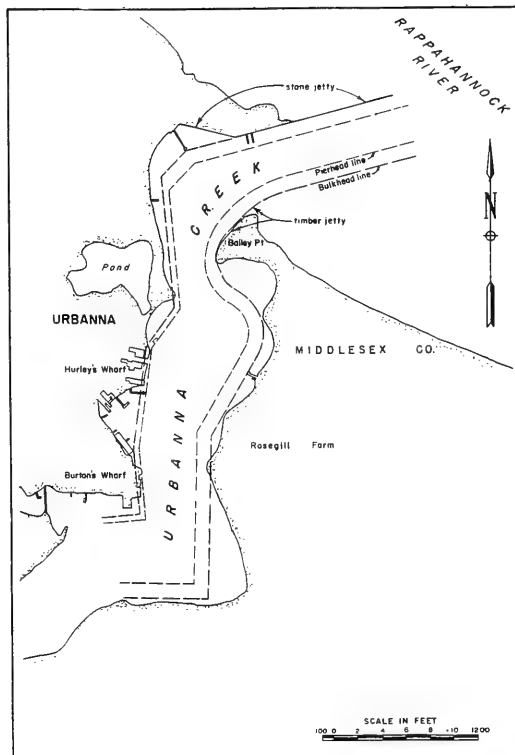
Figure 68. Urbanna Creek, Virginia

<u>Date(s)</u>	<u>Construction and Rehabilitation History</u>
1956	Two jetties were constructed for channel control. The north jetty, 1,895 ft long, was rubble mound. The 717-ft-long south jetty was built of timber (Figure 68).
1962	The north jetty was rehabilitated.
1986	No further repair or maintenance information has been found.

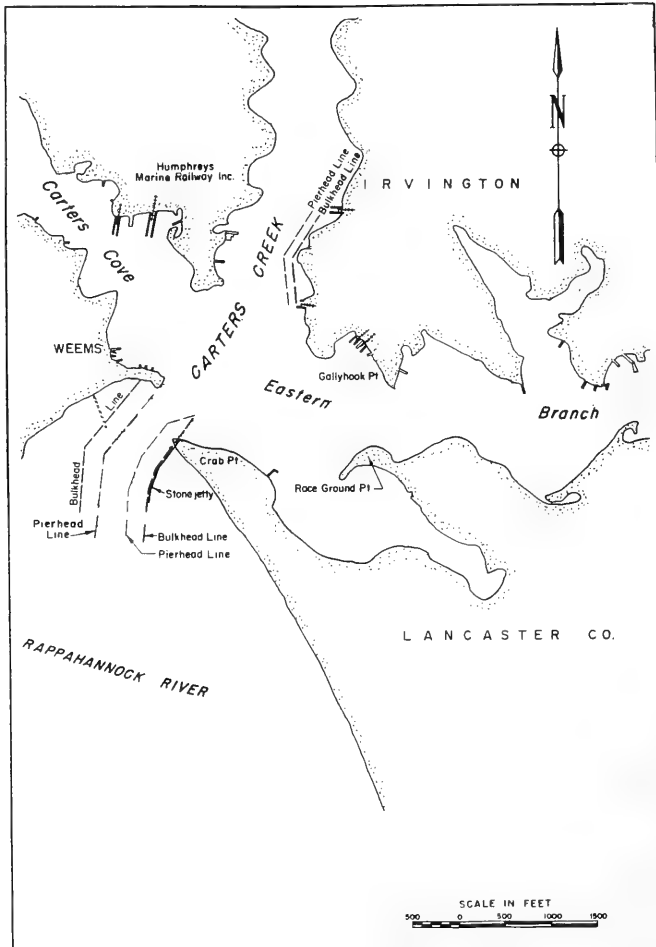
Figure 69. Carters Creek, Virginia

<u>Date(s)</u>	<u>Construction and Rehabilitation History</u>
1902-	A 742-ft-long rubble-mound jetty was built to provide channel control (Figure 69).
1906	
1986	No further repair or maintenance information has been found.

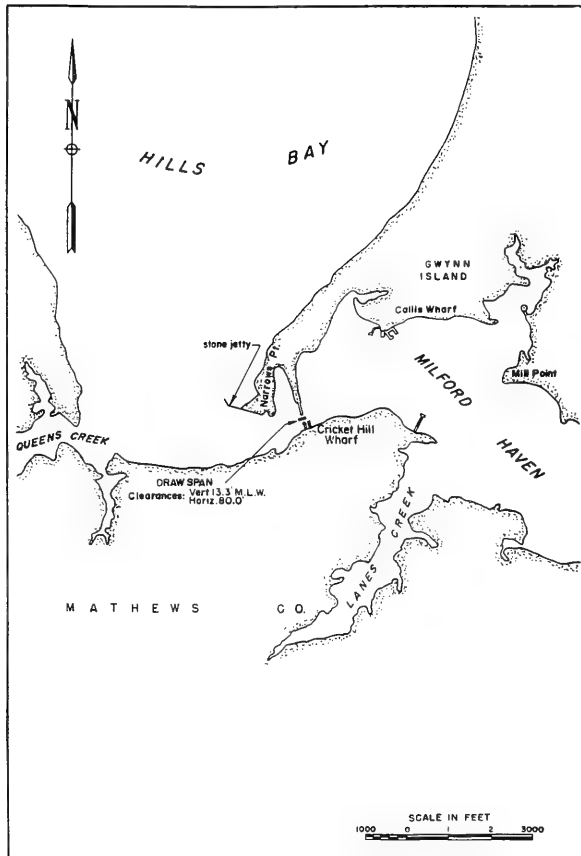
Figure 70. Milford Haven, Virginia

<u>Date(s)</u>	<u>Construction and Rehabilitation History</u>
1913	A 1,183-ft-long rubble-mound jetty was constructed to provide channel control (Figure 70).
1986	No further repair or maintenance information has been found.

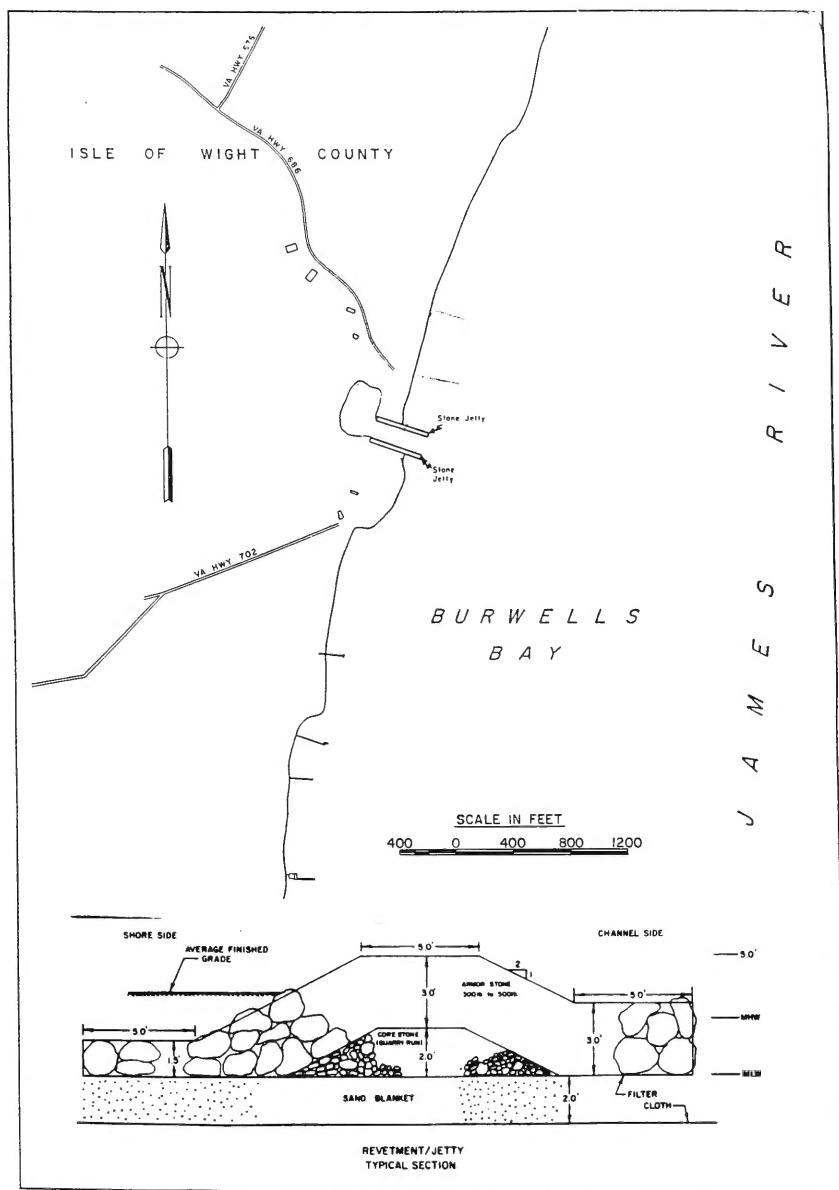
Figure 71. Tylers Beach, Virginia

<u>Date(s)</u>	<u>Construction and Rehabilitation History</u>
1981	Two parallel rubble-mound jetties were constructed to provide channel control. Both jetties were 370 ft in length and spaced 120 ft apart (Figure 71). Crest elevation was +5.0 ft mhw but allowed for 0.5 to 1.0 settlement; crown width was 5.0 ft; and side slopes were 1V:2H. One layer of armor stone, 300 to 500 lb, was placed over one layer of core stone, 3.0 to 40 lb. The jetties rested on a 2.0-ft-thick sand blanket. The sand was encased by filter fabric. A 5.0-ft-wide, 1.5-ft-thick apron and a 5.0-ft-wide, 3.0-ft-thick apron were placed on the shore and channel sides, respectively (Figure 71). A 6.0-sec, 4.1-ft design wave was used. Estimated cost of construction was \$245,000.
1986	No further repair or maintenance information has been found.
